STACK TALK

August 1, 2023

Where's my water!!! from Bill Pardee, one of MLS' boiler inspectors.

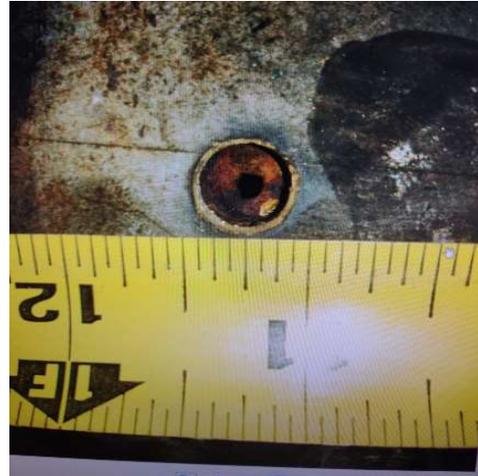
Photo 1.

It has come to my attention thru multiple sources that sight gauges are giving faulty readings. Troubleshooting has found that the bottom water side of the gauge glass is scaled over to the point of being almost or totally blocked. (see photo 1.)

Any slow or sluggish return of water is observed, a repeat of procedure should be performed. If this does not correct the problem a complete disassembly of gauge glass and fittings might be necessary.

While engine is in operation note the water level activity. Changes in level due to grade and engine motion. If water level is quiet or stagnant, troubleshooting is in order. It is very possible that a piece of scale could have caused a blockage creating a false indication in gauge glass. This is why a good boiler washing is necessary on a regular basis.

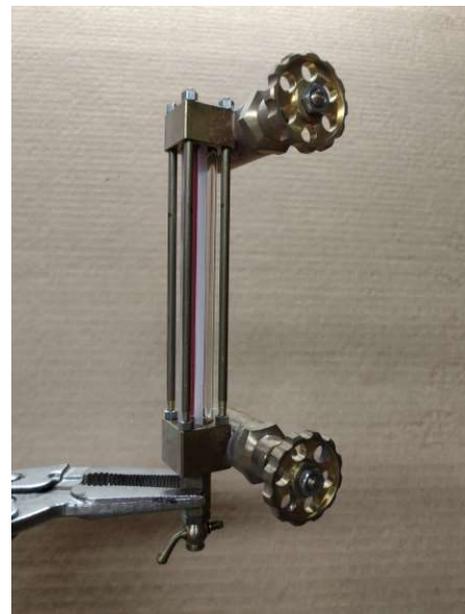
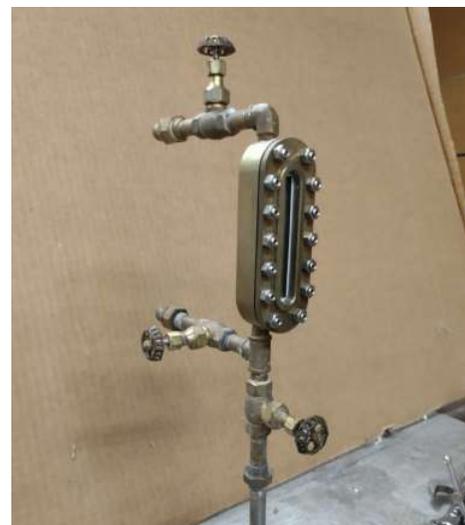
Photo 2.

The gauge glass is our main way of determining where the water level is in our boilers. The other means is thru the use of gauge cocks on the water column or back head of the boiler if equipped. If a gauge glass is installed correctly there will be three valves in addition to the gauge glass to form a proper operating assembly.

There is a top valve that is on the steam side of the glass, a bottom valve on the water side of glass, and a drain valve for emptying the glass. The top and bottom valves provide a means to shut off steam and water in case of glass breakage and to verify the proper flow rates of steam or water to the glass for proper operation. They can also be used to blow the glass down to clean and clear debris from the interior of the glass.

These valves should be easy to reach, free and easy to operate, and used often. (Photo 2 & 3 shows the basic plumbing of a gauge glass.)

The first step when an engineer takes control of an engine is to blow down the water glass. Doing this procedure will help to verify the water glass indication is correct and operating properly.

1. Verify both upper and lower water glass valves are fully open.
2. Close lower water glass valve and then open drain valve and blow the glass clear. This is another way to clean the glass if necessary.
3. Close the drain valve and open lower valve. Observe the immediate return of water to the glass.
4. Close the upper gauge glass valve and then open the drain valve and allow the water to flow until clear.
5. Close the drain valve and open the upper gauge glass valve. Water should return immediately to the gauge glass.
